**State of California  
Alfred E. Alquist  
Seismic Safety Commission**

***The Field Act and its Relative Effectiveness in  
Reducing Earthquake Damage in  
California Public Schools  
Appendices***

**October 2009**

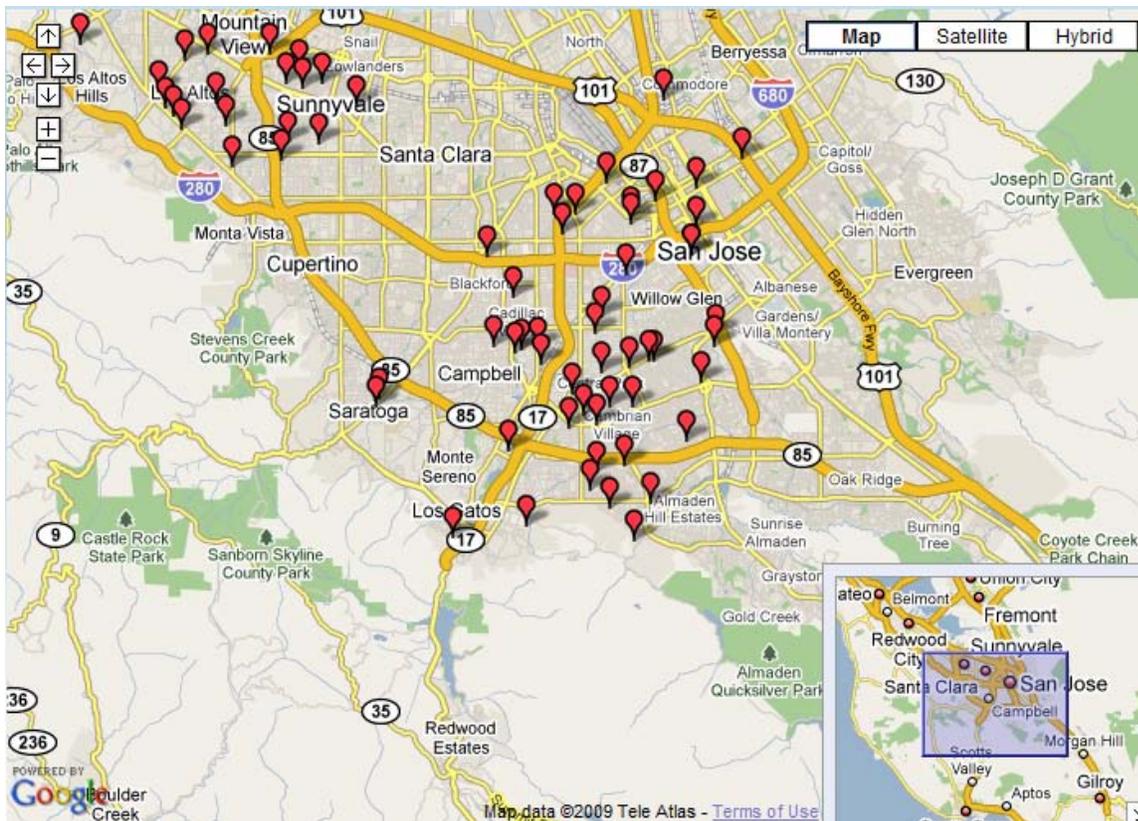
Contained in Figure E-1 is a plot of the public school sites in the greater San Jose area that experienced MMI VII or greater ground shaking intensity during the Loma Prieta Earthquake.

Figure E-1: Public school sites in the greater San Jose area that experienced MMI VII or greater ground shaking intensity during the Loma Prieta Earthquake.

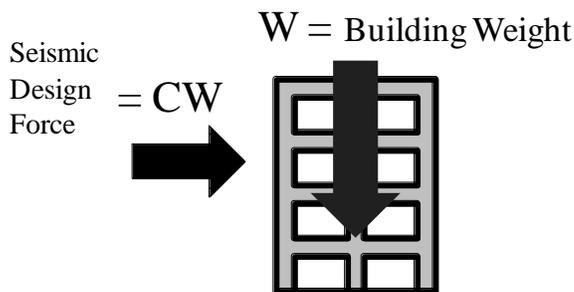
Before the Field Act, school buildings were usually constructed according to the codes used by local jurisdictions. As a result of the 1925 Santa Barbara Earthquake, the first Uniform Building Code (UBC) was published in 1927 and contained the first comprehensive set of earthquake design procedures. It was suggested that these earthquake design procedures be used in seismic areas, but it was not required. The design of buildings to resist earthquake forces was based on applying a horizontal load to the structure equal to a percentage of the weight of the structure. This approach is illustrated in Figure F-1 where the Seismic Design Force is the product of  $C$ , a seismic coefficient that is a percentage of gravity, and  $W$ , the building weight. This remains the most common method for designing buildings to resist seismic forces.

Figure F-1. Horizontal seismic design force as a percentage of total building weight

The first Field Act seismic provisions for public schools were based on the seismic requirements suggested by the 1927 UBC and required school buildings to be designed for lateral forces of two to ten percent of the building weight with most school buildings falling in the six to ten percent range. In comparison, the enactment of the Riley Act in 1933 set minimum seismic design standards for all (non-Field Act) buildings in California which, for most buildings, required a seismic design force of three percent of their weight.

From 1933 to 1976, the design earthquake forces on buildings in California were similar to those of school buildings and varied from 2 to 13% of the building weight, depending on the type of structural system and soil strength. Cities in high seismicity areas, such as San Francisco and Los Angeles often adopted more detailed guidelines than the UBC, based on growing knowledge in the field of structural dynamics and earthquake engineering. Similarly, public schools were designed using more detailed guidelines. Following the 1971 San Fernando Earthquake, which caused extensive damage to numerous buildings in the Los Angeles area, major changes appeared in the 1976 UBC. Some of the significant changes found in the 1976 UBC included increased design force levels (particularly for concrete and masonry structures), requirements to limit the horizontal swaying of the building when subjected to earthquake shaking, and revisions to the map defining earthquake hazard zones. In addition, an occupancy factor was added that increased the seismic design force for “essential” facilities, such as hospitals and fire stations and also for buildings where groups of more than 300 persons assembled. Most of the changes made to the 1976 UBC were adopted, effective July 1, 1978, by the Building Standards Commission and were included in the CBC for public schools.
